Hamilton Design Ltd Service Bulletin

Model: Hamilton Drum Seeder

Subject: Drum Location Pin

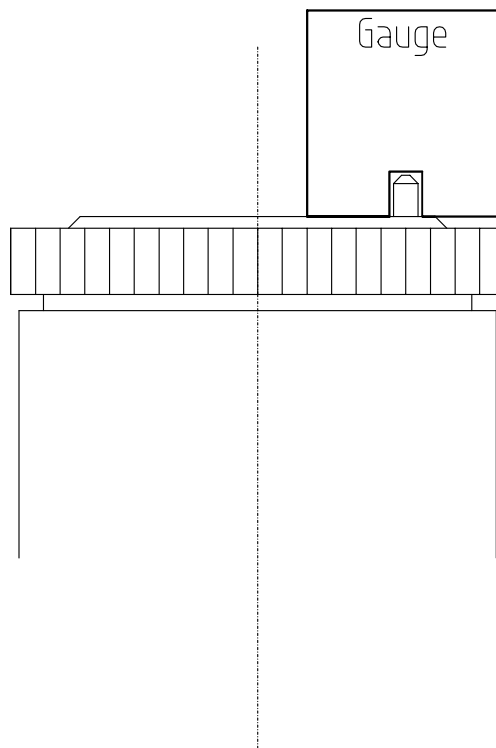
In a recent batch of drums we have found that there are some in which the location pin is sticking out too far. If this happens then the drum end seals will be held away from the rotary valve disc and will not seal properly.

Place the gauge over the pin as shown below. If the tip of the pin touches the gauge then the pin will need to be shortened.

Remove the end seals and cover the holes and bearing with tape. Carefully file the end of the pin until there is clearance between the end of the pin and the gauge. File a chamfer around the end of the pin so that it will locate more easily into the rotary valve disc. Remove the tape and replace the seals.
